INVENTORY OF MONUMENTS AT PAGAN

Volume One
Monuments 1-255

PIERRE PICHARD

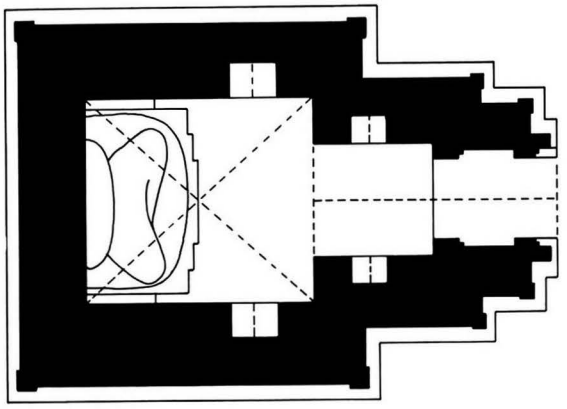
1203 a - Plan

5 present condition
- maintained.
- repaired (Arch. Dept.) 1963 and 1988.

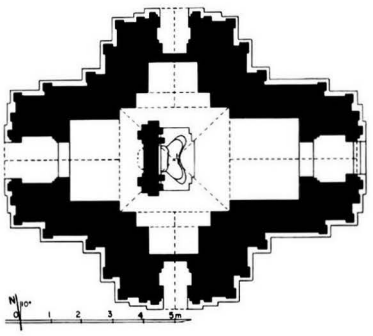
1205 a - Plan

5 present condition
- minimal maintenance.
- upper parts damaged.

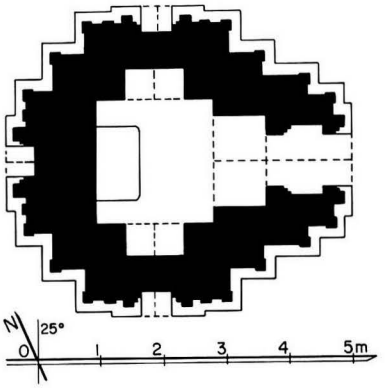
1206 a - Plan

5 present condition
- minimal maintenance.
- base disintegrated.

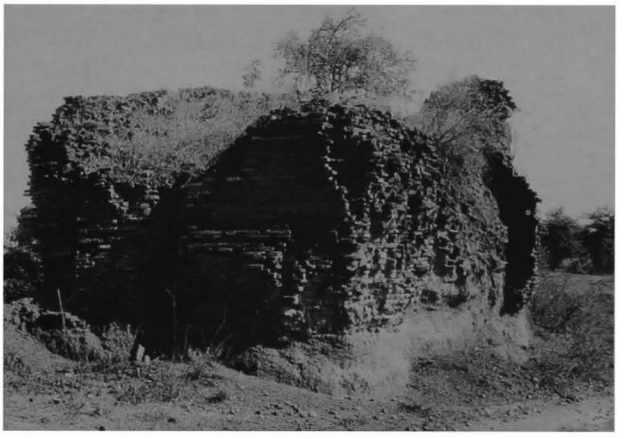
1207 c - South face, from south-east

5 present condition
- ruined.
- vaults and upper parts collapsed.
- ground floor buried under debris.
- partly cut by modern road, exposing absence of foundations.

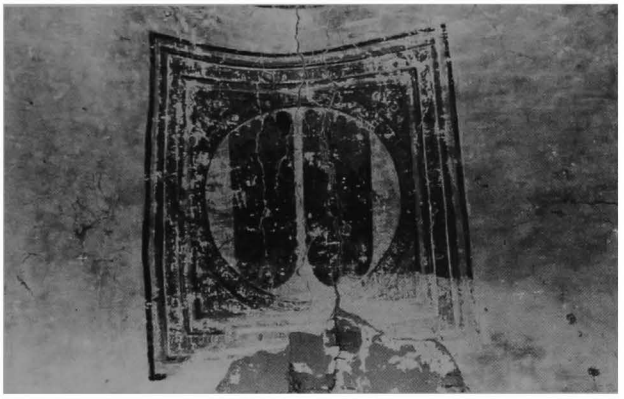
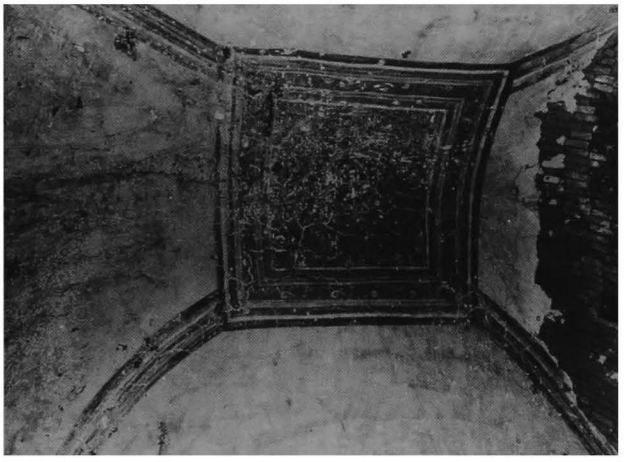
5 present condition
- upper parts damaged.
- repaired (Arch. Dept.) 1991-92.

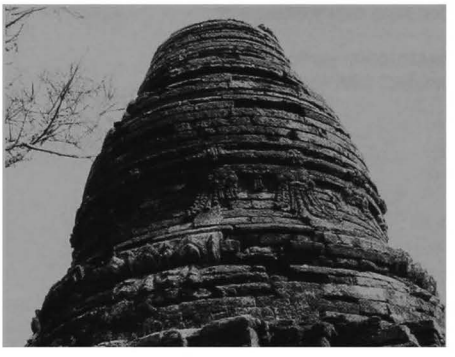
1214 b - Upper parts, from south-east

5 present condition
- no maintenance.
- base and terraces disintegrated.
- upper parts damaged.
- leaning southward.

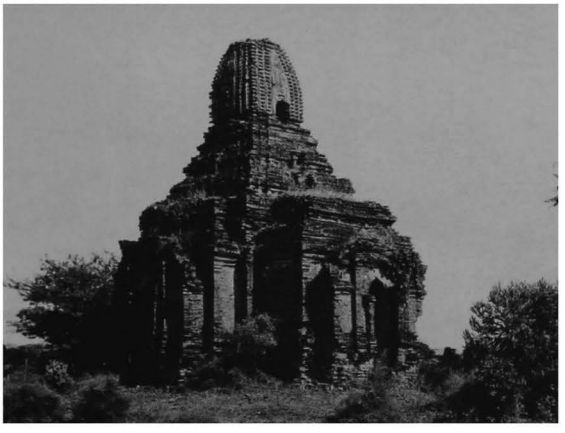
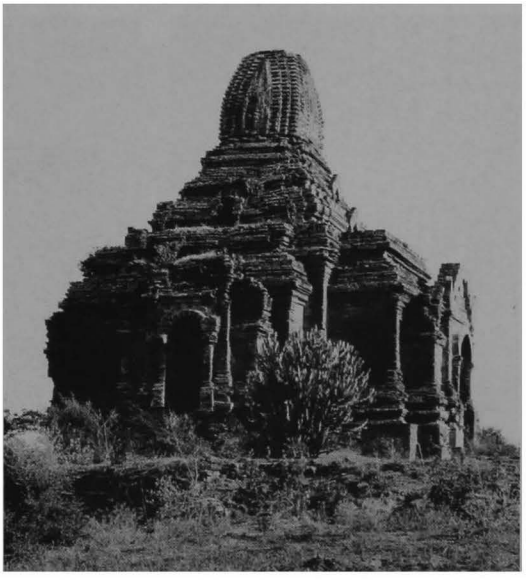
1217 d - From north-west, after repair, 1994

5 present condition
- no maintenance.
- base disintegrated.
- upper parts damaged.

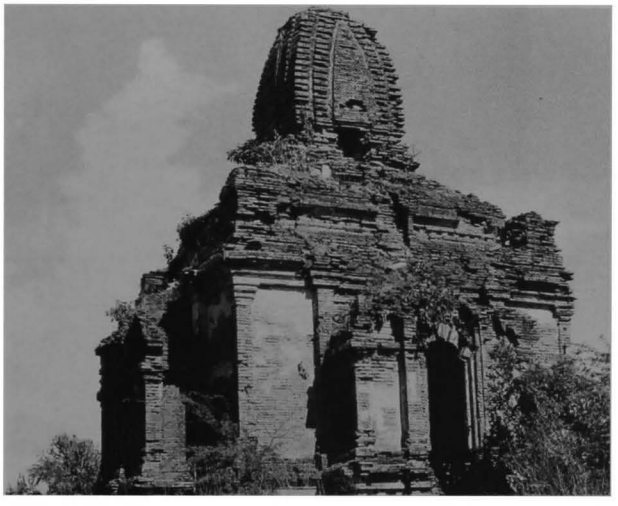
1218 b - South face, from south-west

5 present condition
- no maintenance.
- east porch badly cracked.
- upper parts damaged.

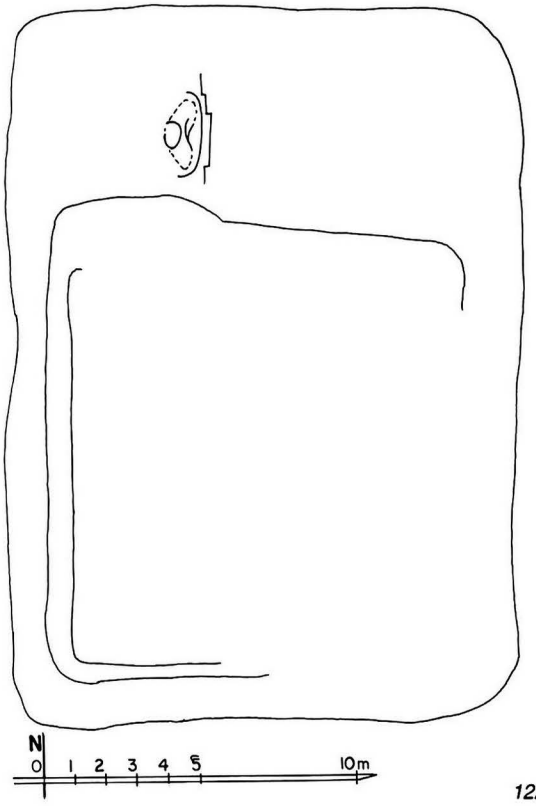
1221 a - Plan

5 present condition
- brick debris from size 36 x 18 x 5 cm.
- height: approx. 2.20 m.

6 image
- 1 seated Buddha, facing east (legs only remain).

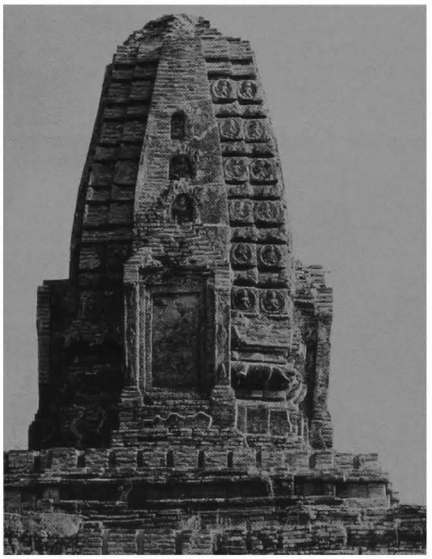
1228 d - North face, 1994

5 present condition
- half-ruined.
- repaired (Arch. Dept.) 1990.

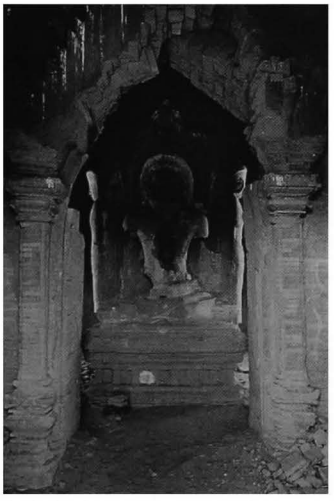
1228 h - Passage, core and images, from east, 1986

6 images
- 1 seated Buddha, facing east (damaged and headless).
- 2 standing Buddhas facing north and south.
- 1 seated Buddha, facing west (destroyed).

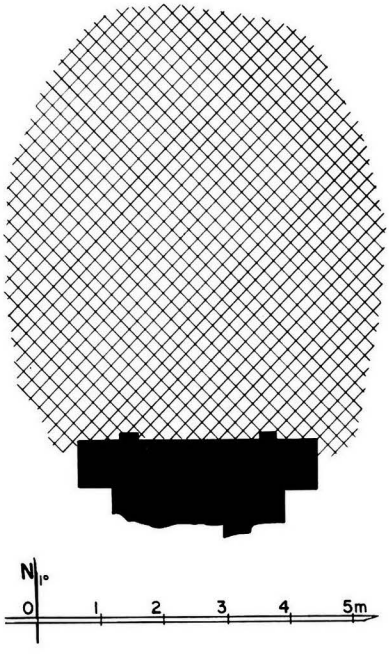
1229 a - Plan

5 present condition
- only part of a south wall remains.
- height: approx. 3.20 m.

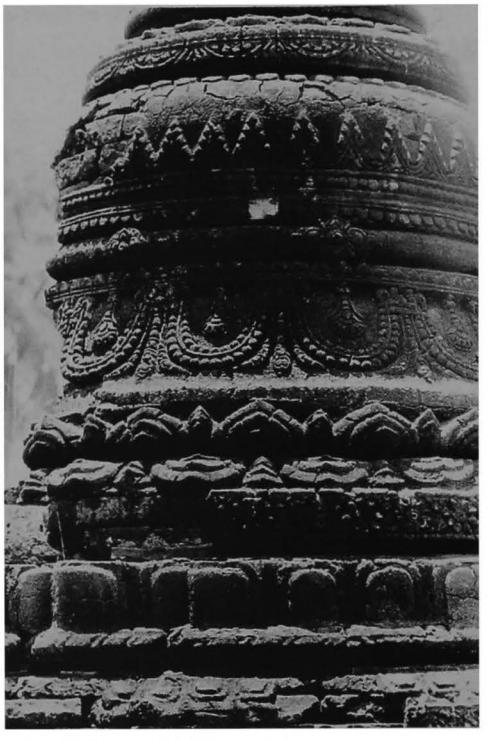
1233 d - Dome, detail from east

5 present condition
- leaning badly eastwards.
- repaired (Arch. Dept.) 1988.

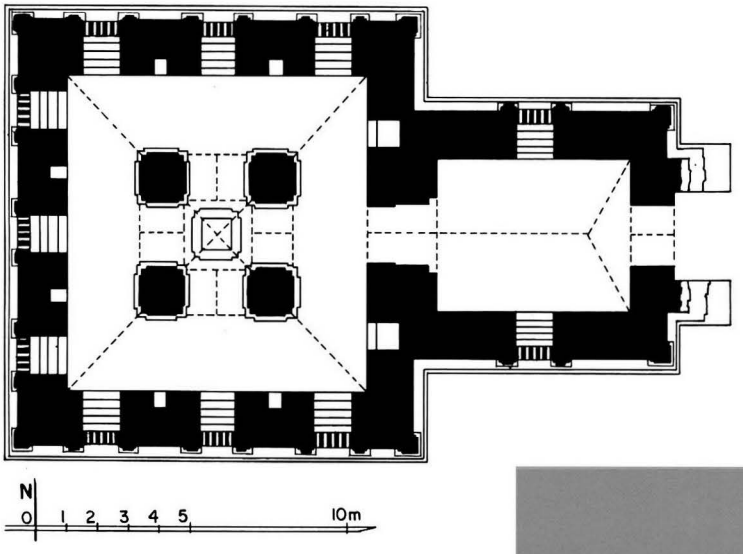
1239 a2 - Plan

5 present condition
- east porch destroyed.
- regularly maintained.
- restored 1908-10.
- repaired and strengthened (Const. Corp.) 1992-94.
- consolidation of sandstone facing 1993-94.

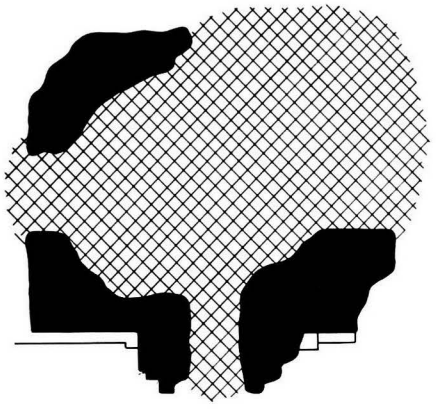
1242 a - Plan

5 present condition
- ruined.
- vaults and upper parts collapsed.
- ground floor buried under debris.

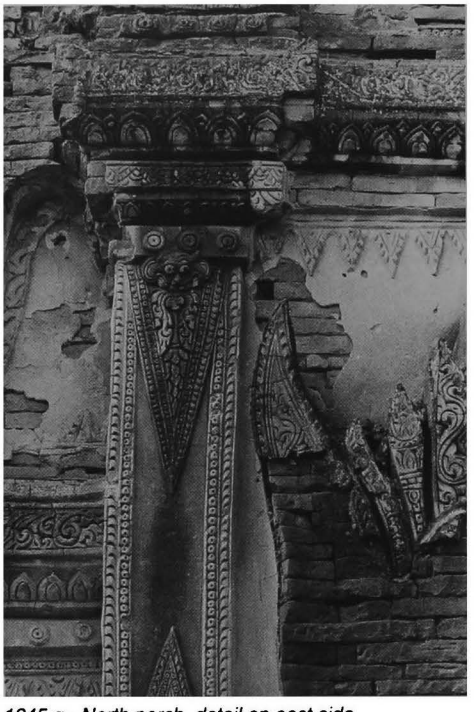
1245 g - North porch, detail on east side

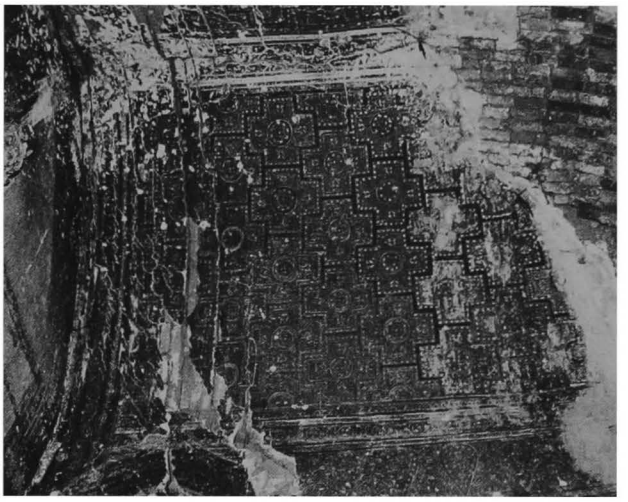
5 present condition
- no maintenance.
- vaults in upper storey and upper parts collapsed.
- upper floor buried under debris.

1245 m - Ground floor, west shrine vault, from north

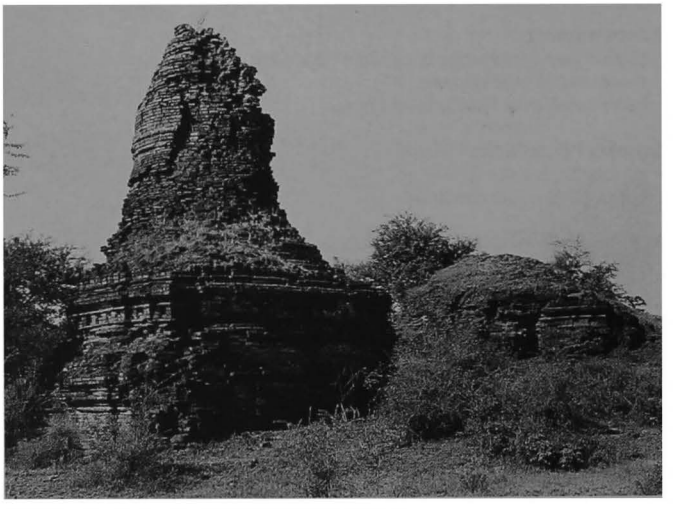
1248 c - From south-west, together with 1246

5 present condition
- no maintenance.
- half-ruined.
- base and terraces disintegrated.
- upper parts badly damaged.

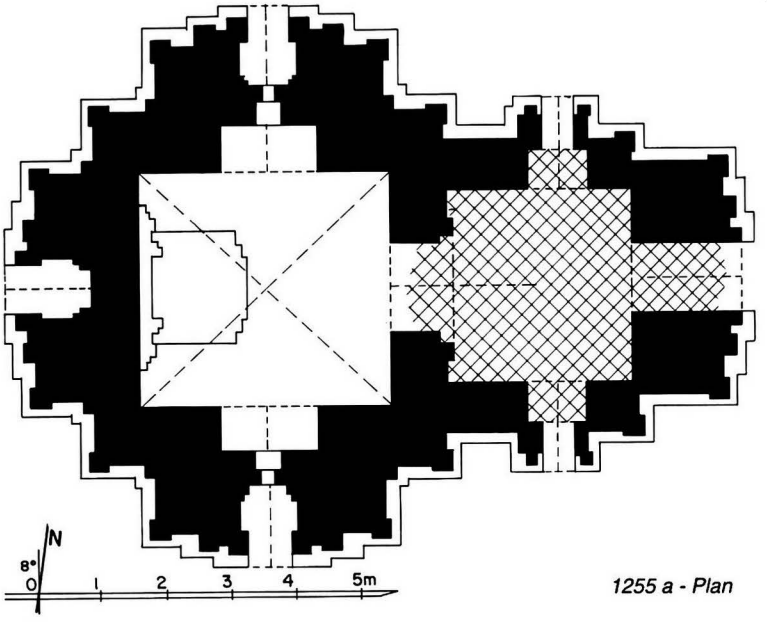
1255 a - Plan

5 present condition
- no maintenance.
- vaults and upper parts collapsed over entrance hall.
- base disintegrated.
- structure cracked.
- upper parts damaged.

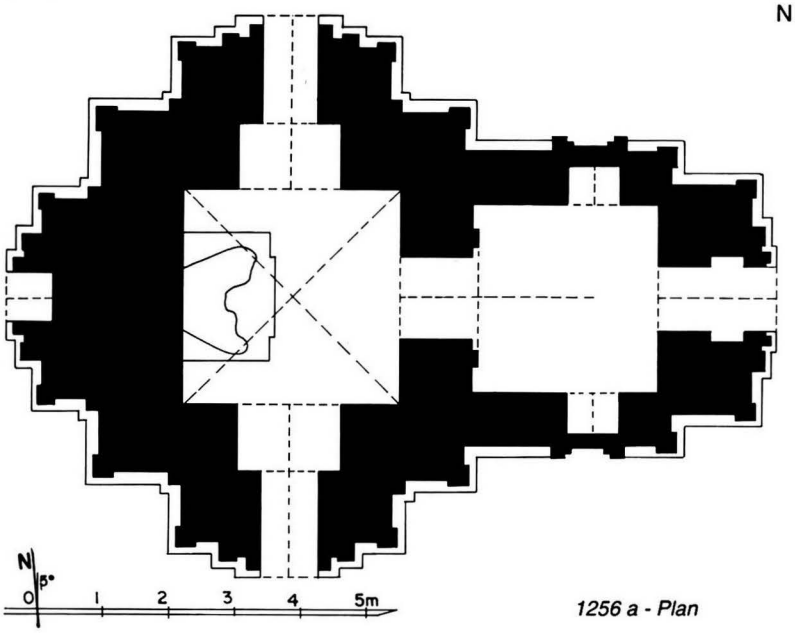
1256 a - Plan

5 present condition
- no maintenance.
- vaults and upper parts collapsed over entrance hall.
- base disintegrated.
- structure cracked.
- tower leaning eastward.

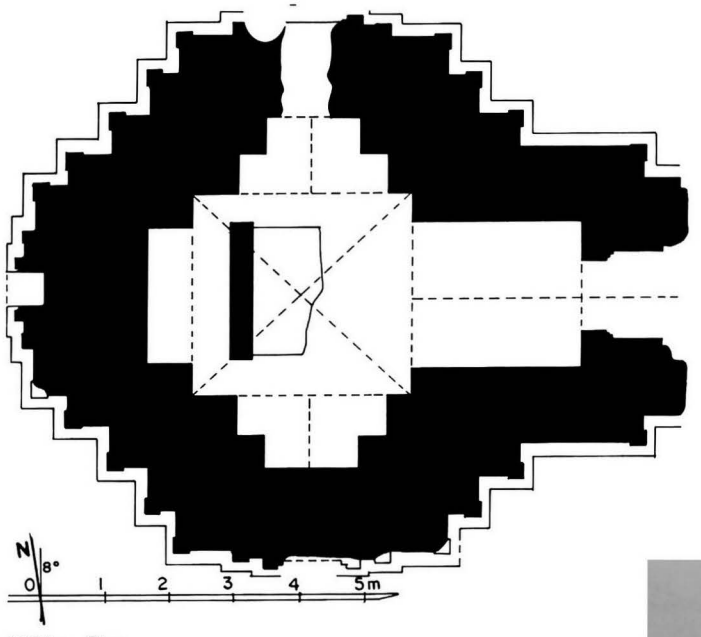
1258 a - Plan

5 present condition
- no maintenance.
- base disintegrated.
- east porch collapsed.
- upper parts badly damaged and in danger.

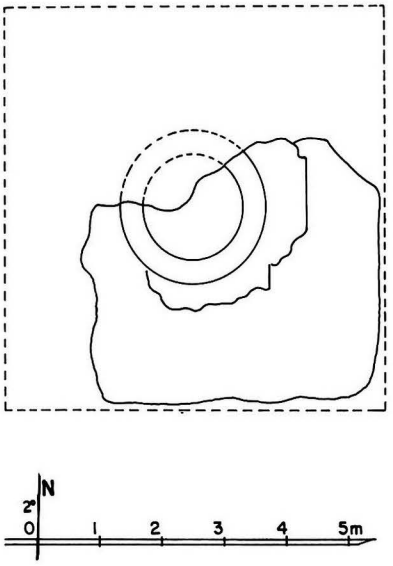
1259 a - Plan

5 present condition
- ruined.
- base and terraces disintegrated.
- upper parts badly damaged.

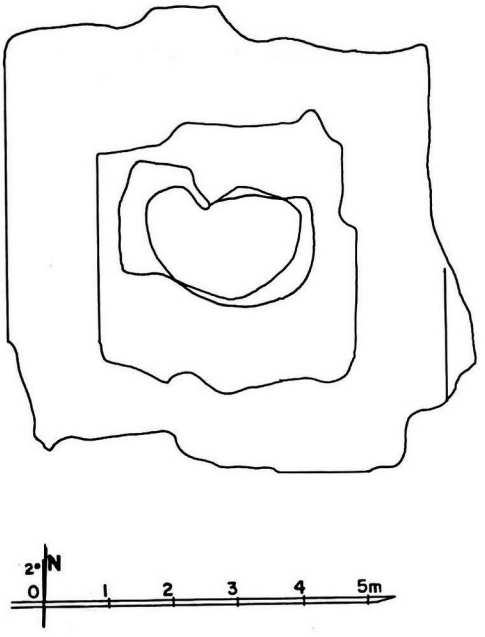
1260 a - Plan

5 present condition
- ruined.
- base and terraces disintegrated.
- upper parts collapsed.

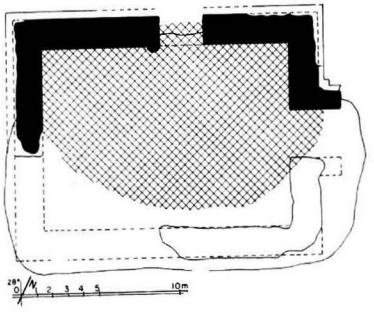
1261 a - Plan

5 present condition
- ruined.
- only north part remains.
- ground floor buried under debris.

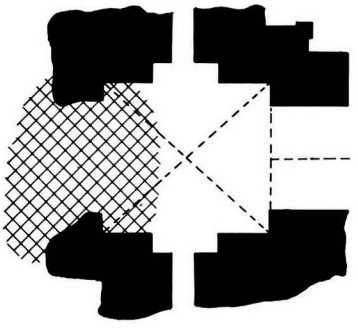
1262 a - Plan

5 present condition
- ruined.
- base and facing disintegrated.
- west wall and upper parts collapsed.
- ground floor buried under debris.

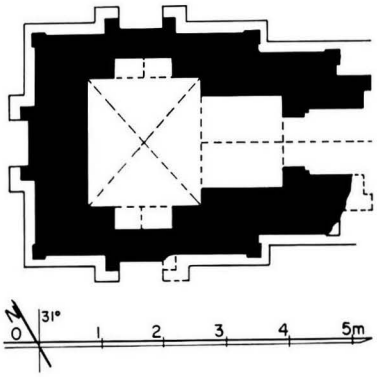
1263 a - Plan

5 present condition
- no maintenance.
- base disintegrated.
- tower partly destroyed.

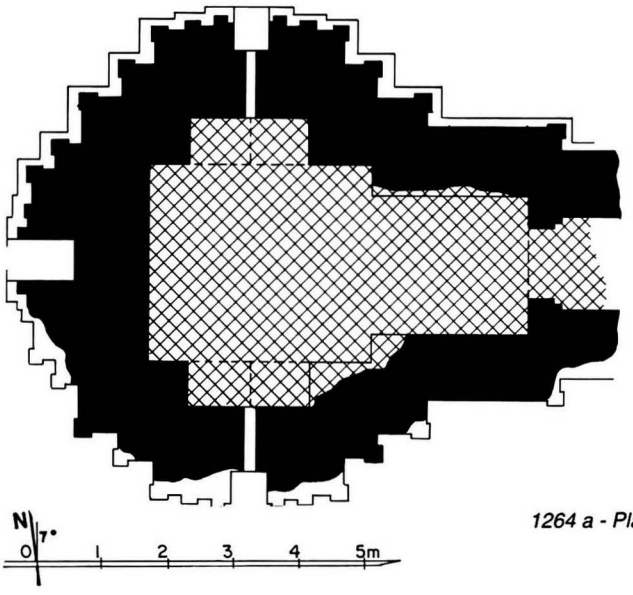
1264 a - Plan

5 present condition
- ruined.
- base disintegrated.
- vaults and upper parts collapsed.
- ground floor buried under debris.

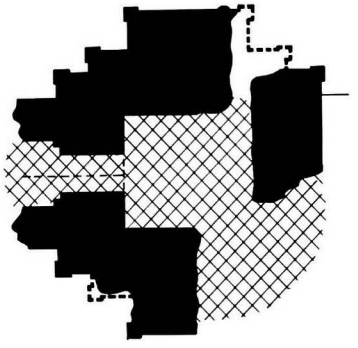
1265 a - Plan

5 present condition
- ruined.
- vaults and upper parts collapsed.
- ground floor buried under debris.

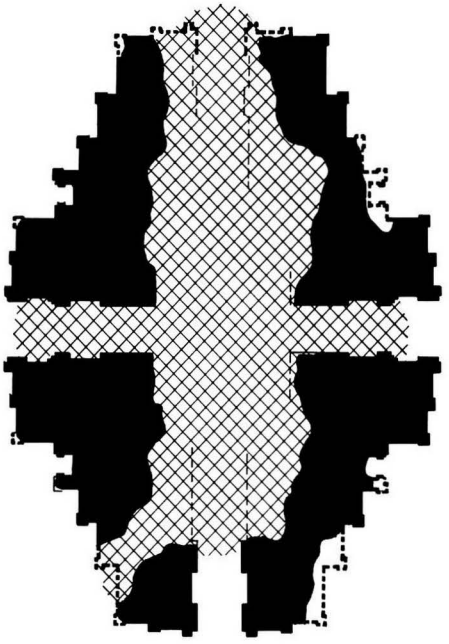
1267 a - Plan

5 present condition
- half-ruined.
- vaults and upper parts collapsed.
- base and ground floor buried under debris.

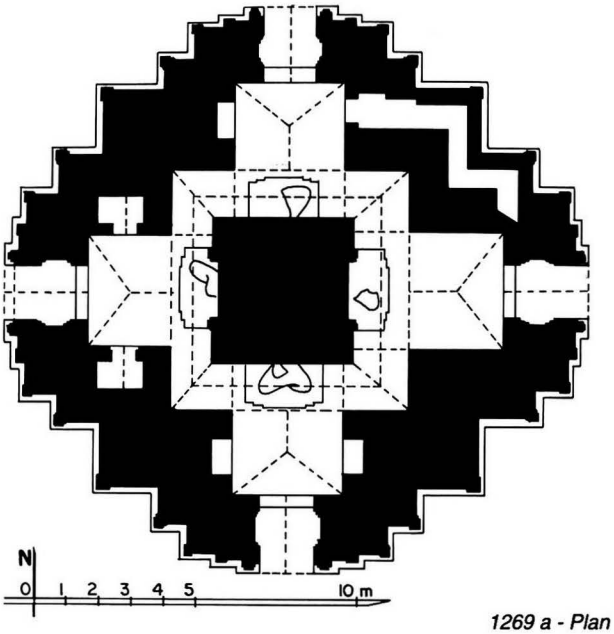
1269 a - Plan

5 present condition
- no maintenance.
- base disintegrated.
- terraces badly damaged.

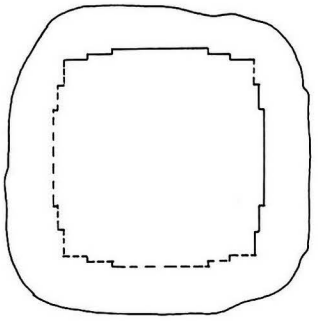
1270 a - Plan

5 present condition
- ruined.
- base disintegrated.
- upper parts collapsed.
- present height: 2.80 m.

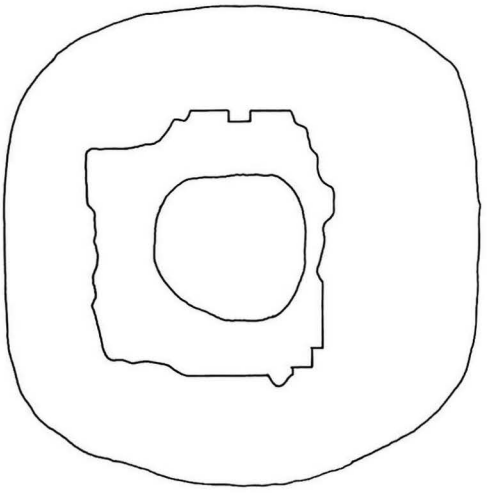
5 present condition
- ruined.
- base and terraces disintegrated.
- upper parts collapsed.
- present height: 1.80 m.

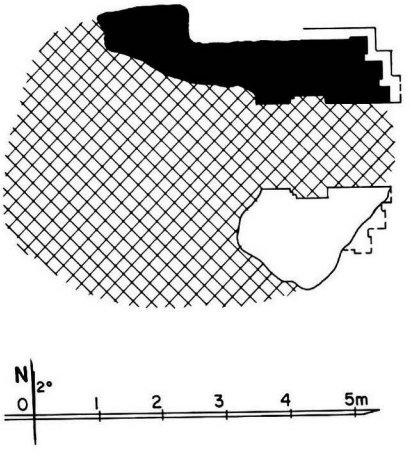
1272 a - Plan

5 present condition
- ruined.
- ground floor buried under debris.
- present height: 2.00 m.

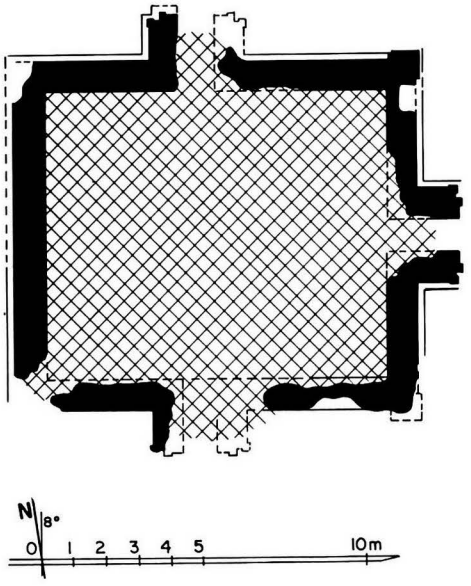
1277 a - Plan

5 present condition
- ruined.
- ground floor buried under debris.
- present height: 1.80 m.

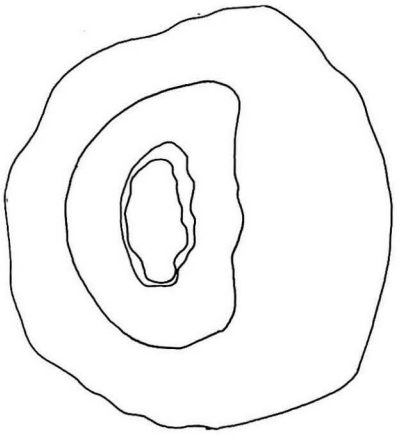
1278 a - Plan

5 present condition
- ruined.
- base buried under debris.
- upper parts collapsed.
- present height: 2.40 m.

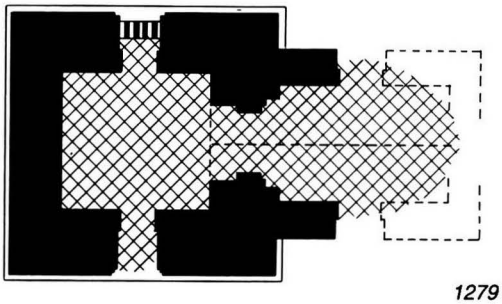
1279 a - Plan

5 present condition
- ruined.
- east part collapsed.
- vaults and upper parts collapsed.
- ground floor buried under debris.

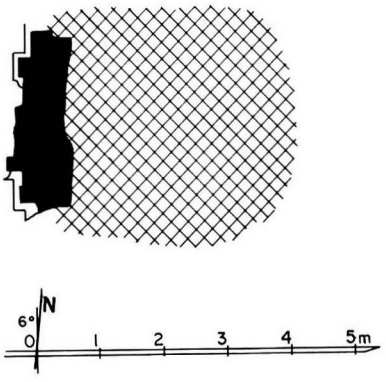
1280 a - Plan

5 present condition
- ruined.
- only part of west wall remains.
- ground floor buried under debris.

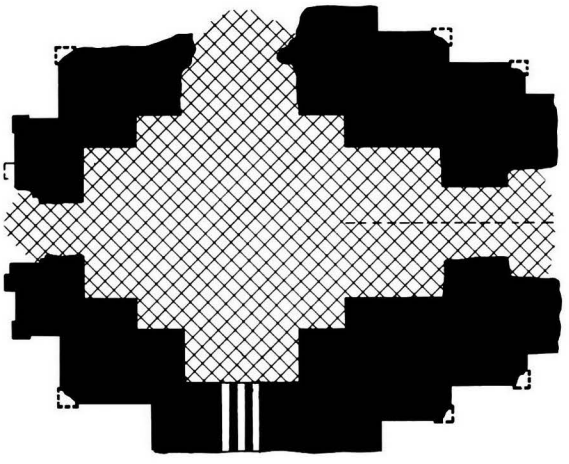
1281 a - Plan

5 present condition
- ruined.
- vaults and upper parts collapsed.
- ground floor buried under debris.

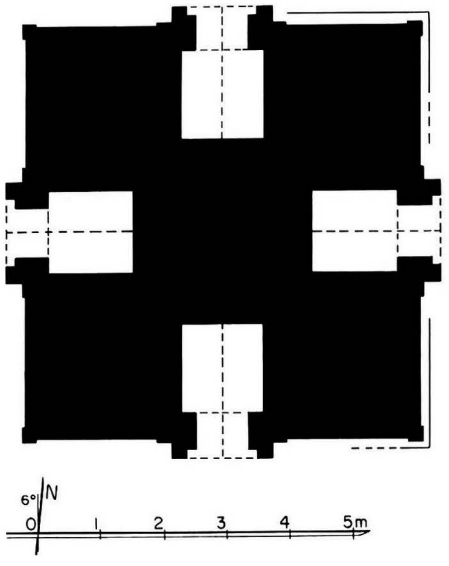
1282 a - Plan

5 present condition
- no maintenance.
- base disintegrated.

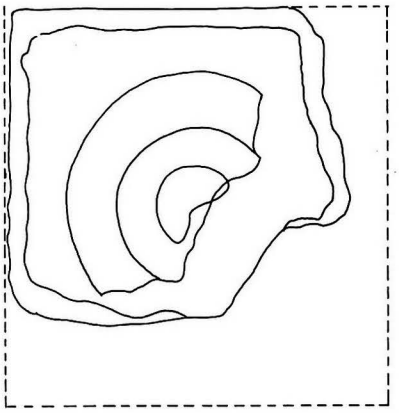
1283 a - Plan

5 present condition
- no maintenance.
- half-ruined.
- upper parts badly damaged.

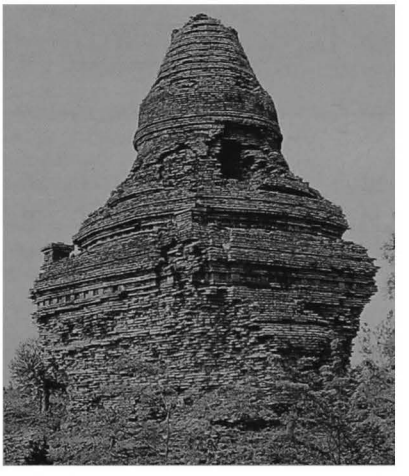
1284 c - From north-east, 1986

5 present condition
- base disintegrated.
- repaired (Const. Corp.) 1993.

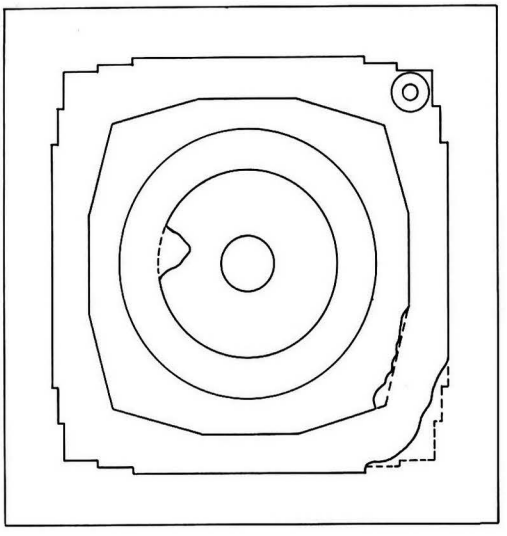
1285 a - Plan

5 present condition
- no maintenance.
- base, terraces and upper parts damaged.

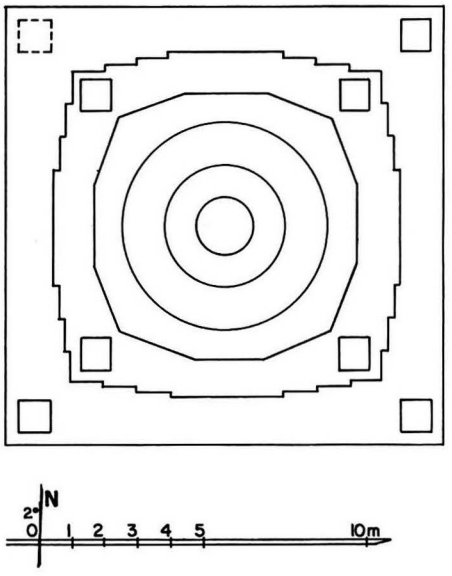
1286 a - Plan

5 present condition
- no maintenance.
- terraces damaged.

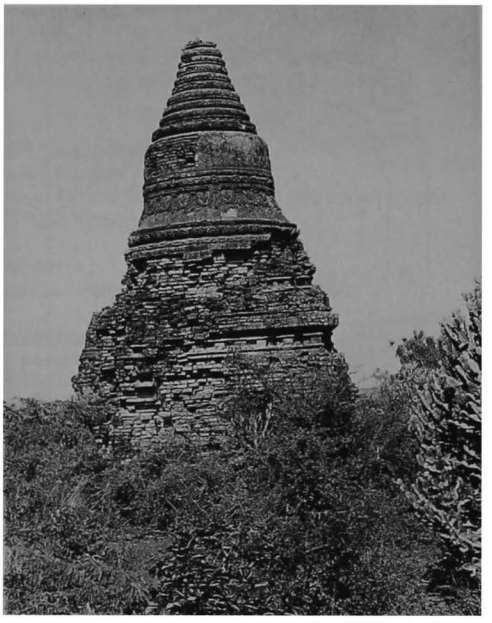
1287 b - East face

5 present condition
- no maintenance.
- base and terraces disintegrated.

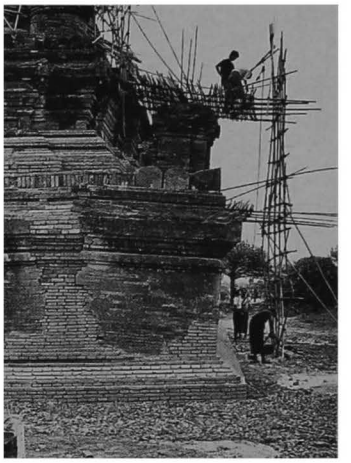
1288 c - South face, south-east corner, under repair, 1993

5 present condition
- corners of base cracked and tilting on their foundations.
- repaired (Const. Corp.) 1993.

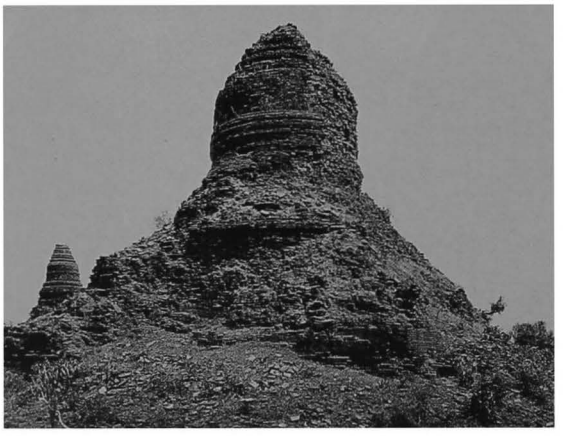
1289 b - From south-east

5 present condition
- no maintenance.
- terraces disintegrated.
- upper parts badly damaged.

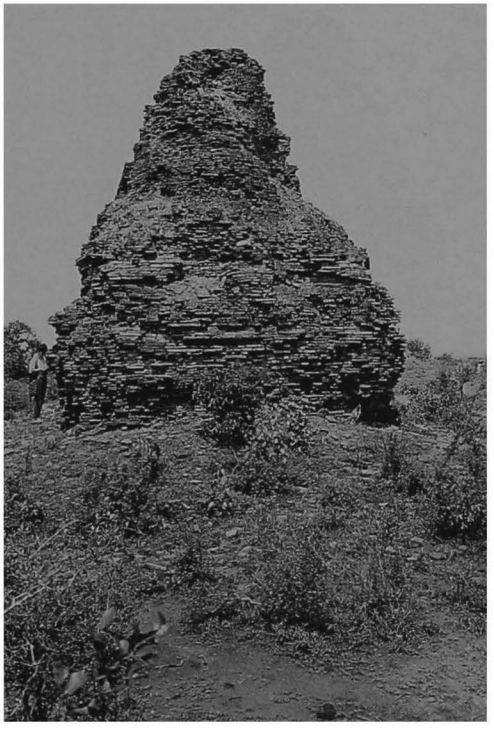
1290 b - East face

5 present condition
- no maintenance.
- base and terraces disintegrated.
- upper parts badly damaged.

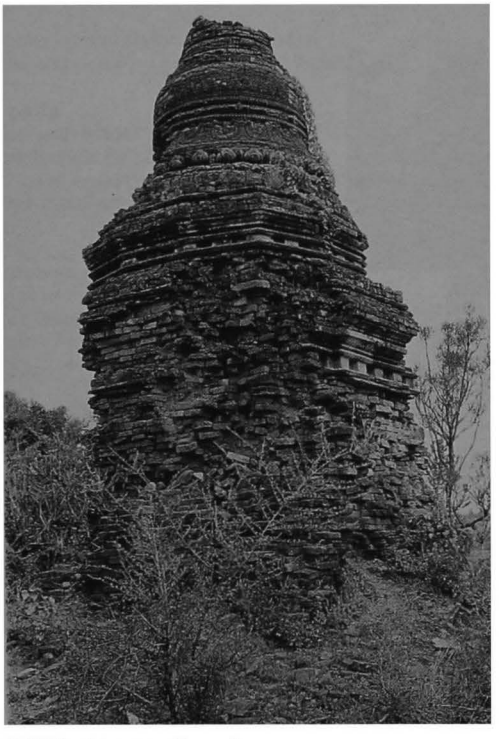
1292 b - From south-east

5 present condition
- no maintenance.
- base and terraces disintegrated.
- upper parts damaged.

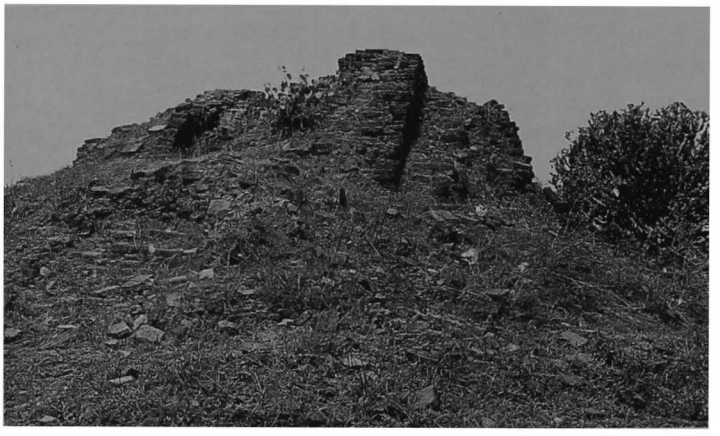
1293 c - East face, from north-east

5 present condition
- ruined.
- vaults and upper parts collapsed.
- ground floor buried under debris.

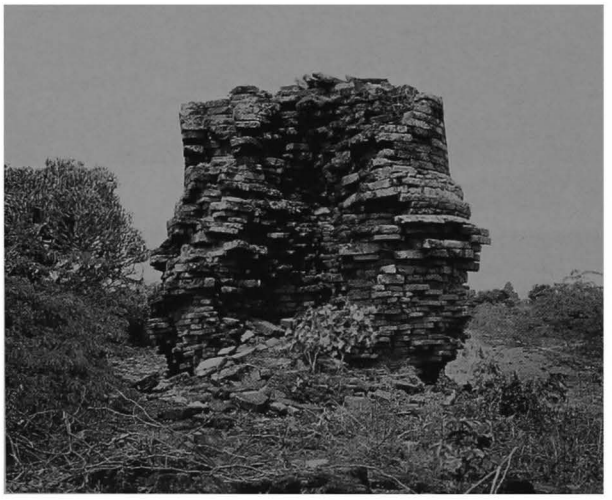
1295 b - From east

5 present condition
- half-ruined.
- base and terraces disintegrated.
- upper parts badly damaged.

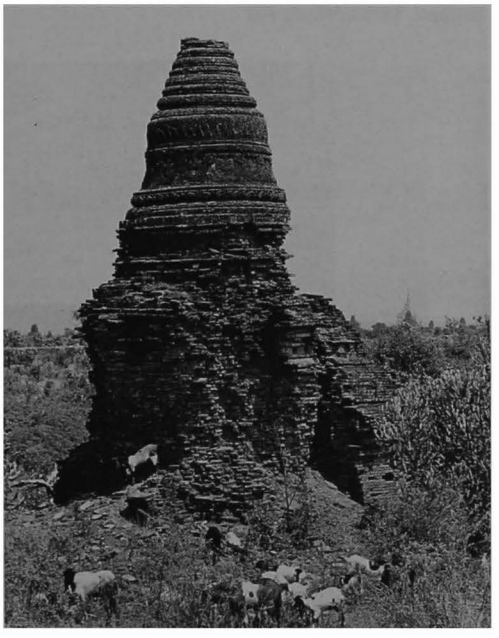
1296 b - From south-east

5 present condition
- no maintenance.
- half-ruined.
- base and terraces disintegrated.
- upper parts badly damaged.

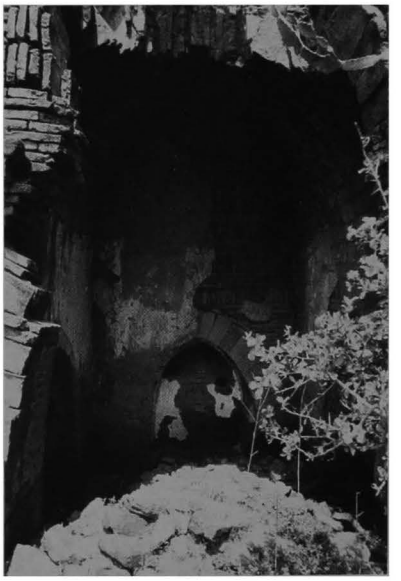
1297 d - Shrine, from east

5 present condition
- no maintenance.
- east porch collapsed.
- upper parts nearly destroyed.

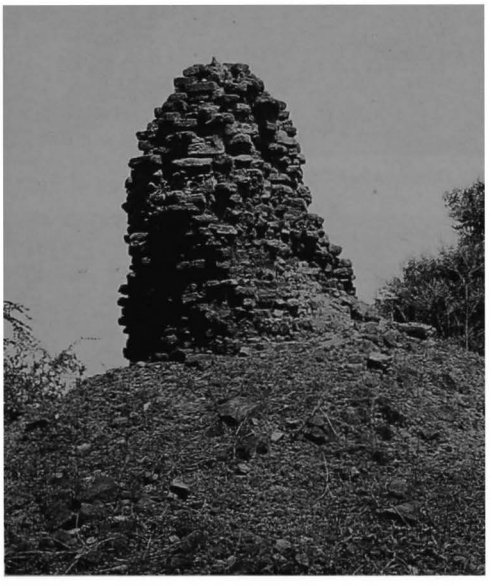
1298 b - From south-east

5 present condition
- half-ruined.
- base and terraces disintegrated.
- upper parts nearly destroyed.

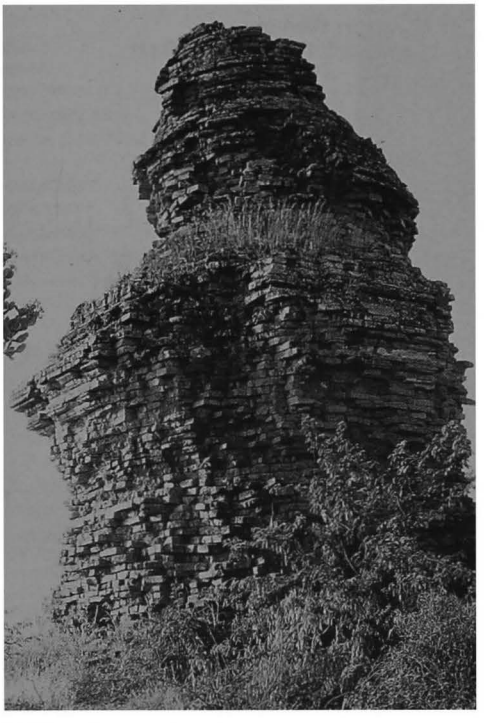
1301 b - From north-east

5 present condition
- half-ruined.
- base and terraces disintegrated.
- upper parts badly damaged.

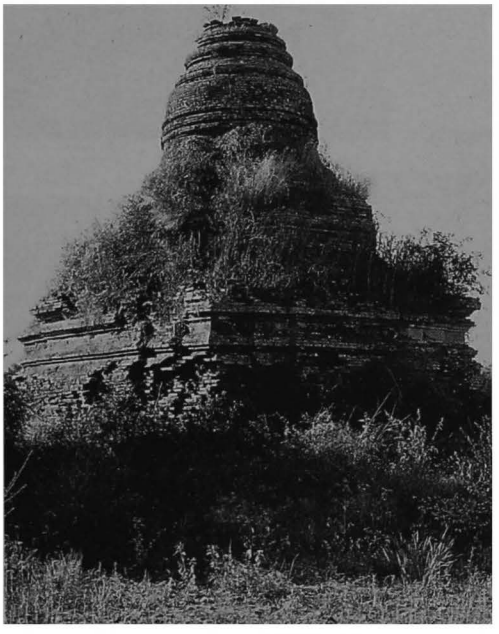
1302 b - From north-east

5 present condition
- no maintenance.
- base disintegrated.

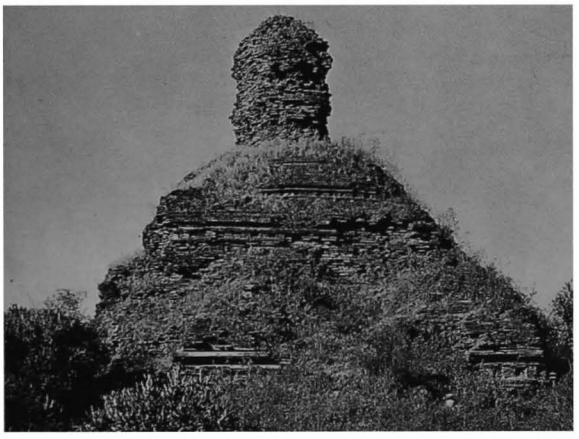
1304 b - East face

5 present condition
- no maintenance.
- terraces disintegrated.
- upper parts badly damaged.

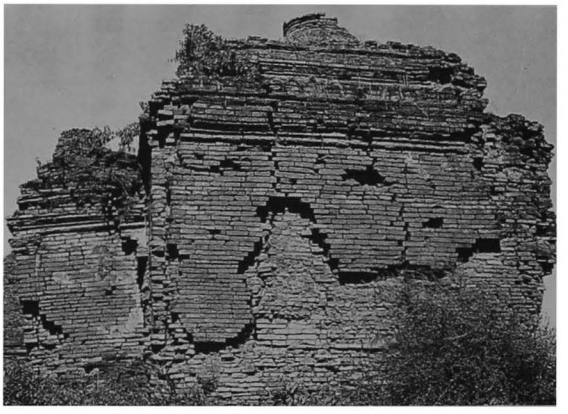
1305 d - From north-west, 1988, after repair

5 present condition
- repaired (Arch. Dept.) 1987.

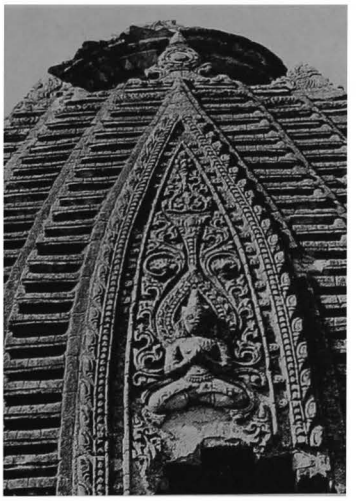
1307 b - From north-east

5 present condition
- no maintenance.
- partially repaired (Arch. Dept.) 1982.

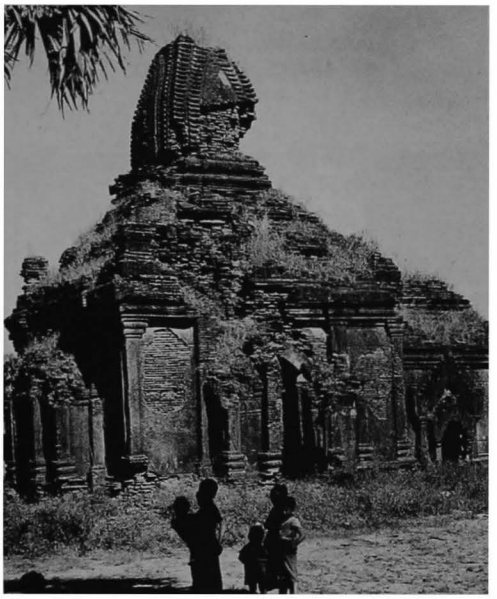
1308 b - South face, from south-west, 1986

5 present condition
- repaired (Arch. Dept.) 1987.

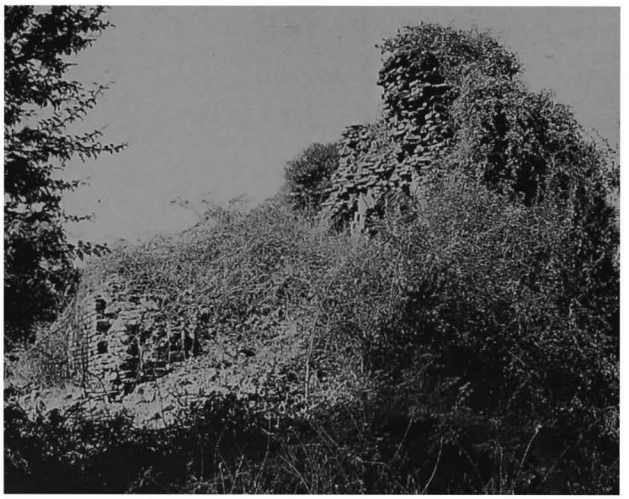
1309 b - From south-east

5 present condition
- ruined.
- vault collapsed.
- ground floor buried under debris.

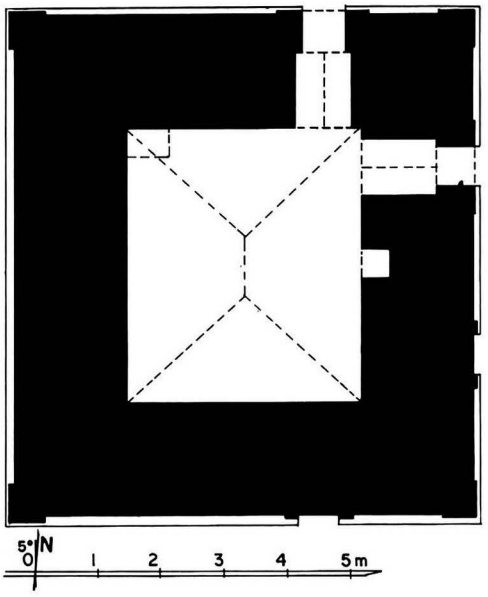
1310 a - Plan

5 present condition
- structure badly cracked.

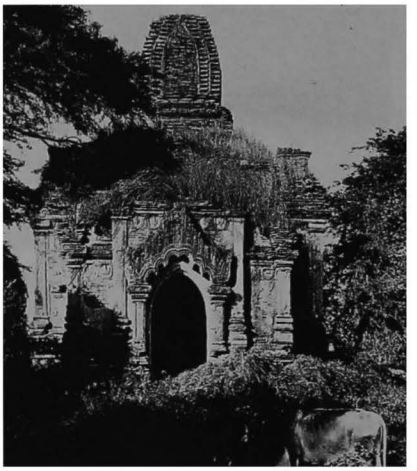
1311 b - East face

5 present condition
- no maintenance.
- base disintegrated.
- upper parts badly damaged.

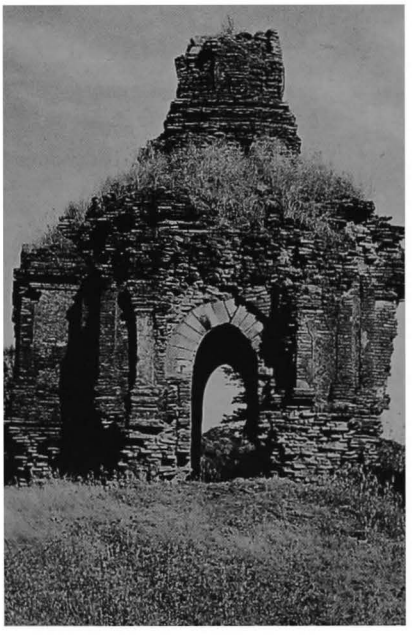
1312 b - South face

5 present condition
- endangered.
- no maintenance.
- base totally disintegrated.
- upper parts badly damaged.

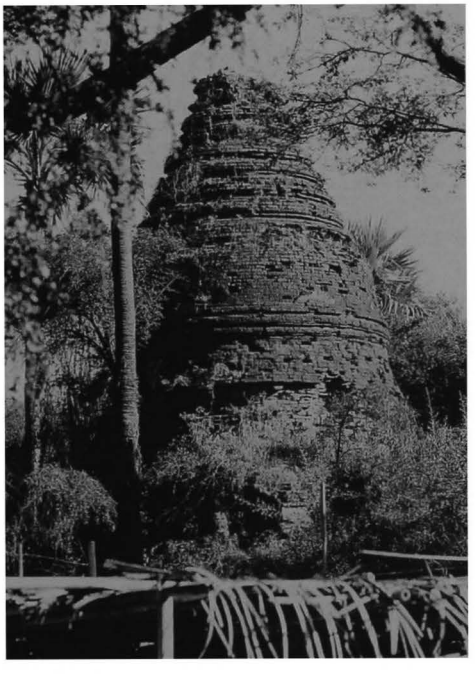
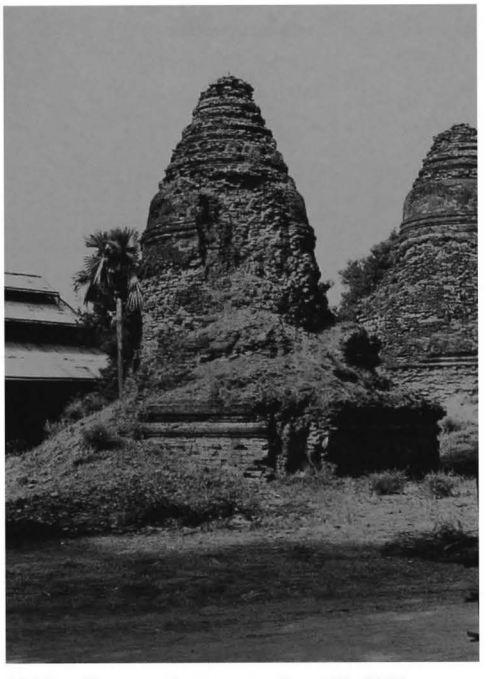
5 present condition
- no maintenance.
- base and terraces disintegrated.

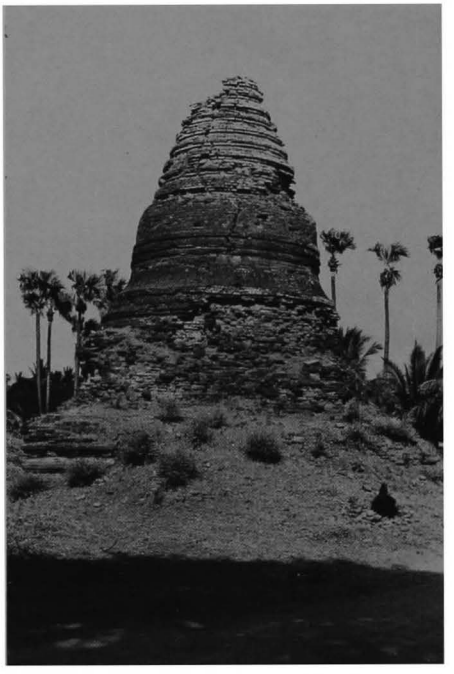
1326 c - From east

5 present condition
- no maintenance.
- base and terraces disintegrated.
- upper parts badly damaged.

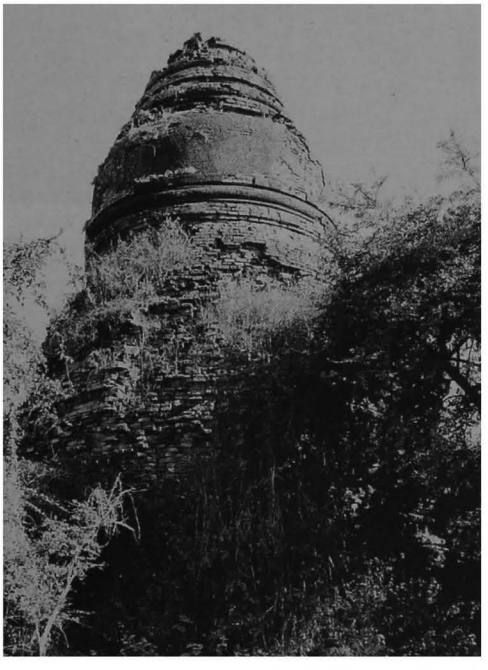
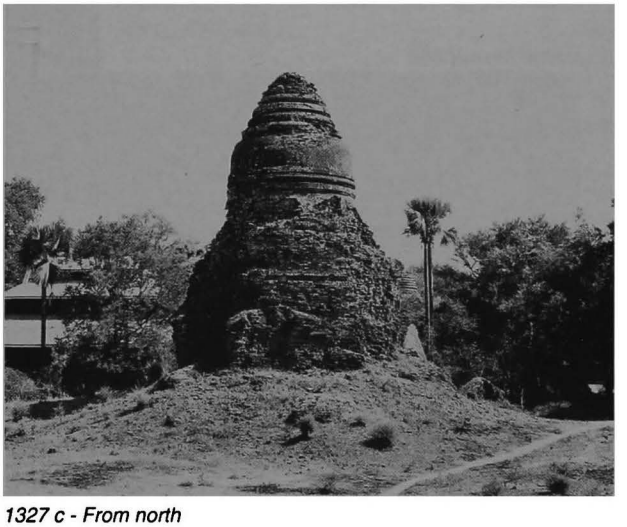
5 present condition
- no maintenance.
- base and terraces disintegrated.
- upper parts damaged.

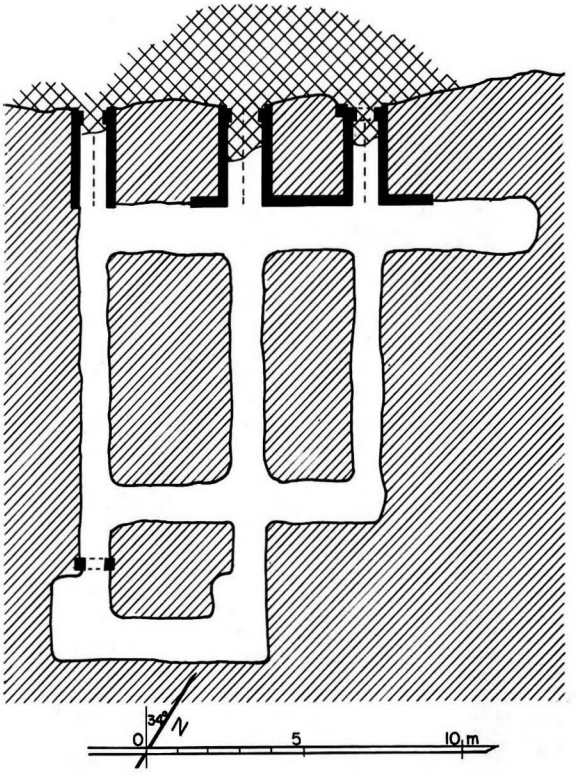
1330 a - Plan

5 present condition
- no maintenance.

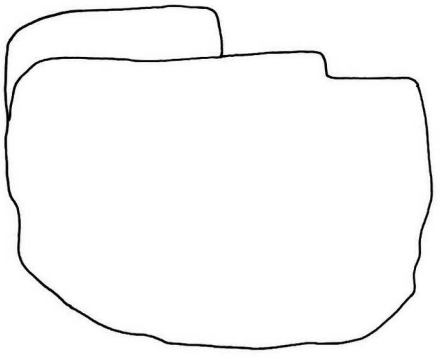
1331 a - Plan

5 present condition
- only part of a north wall remains.
- height: approx. 1.60 m.

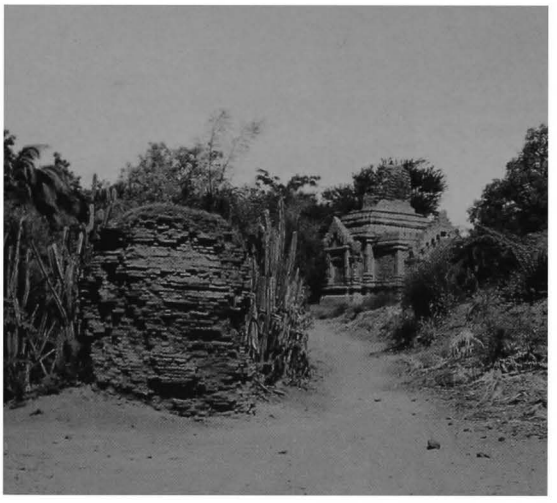
1332 b - From south-east, together with 1333

5 present condition
- no maintenance.
- ruined.
- base and terraces disintegrated.

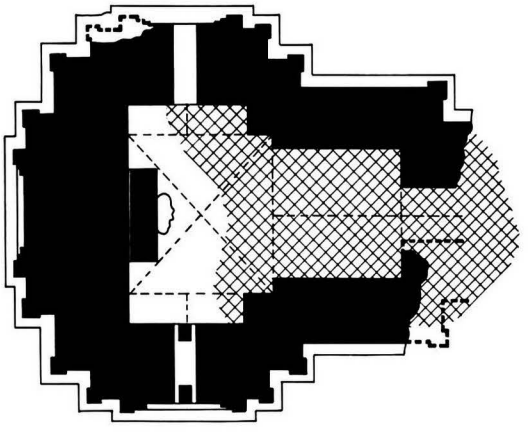
1333 a - Plan

5 present condition
- repaired (Arch. Dept.) 1990.

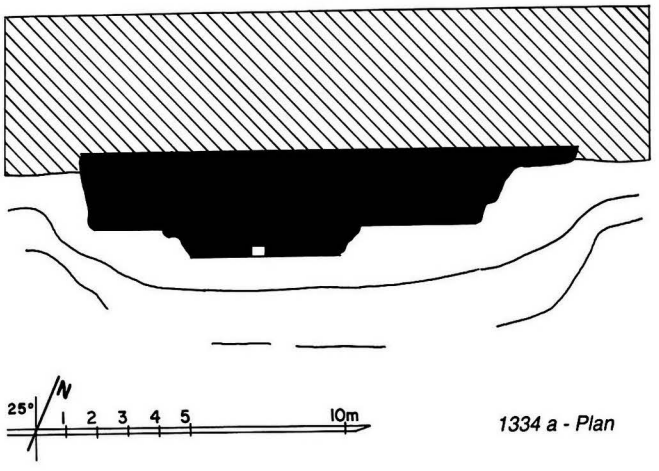
1334 a - Plan

5 present condition
- unexcavated.
- base buried under debris preventing access.

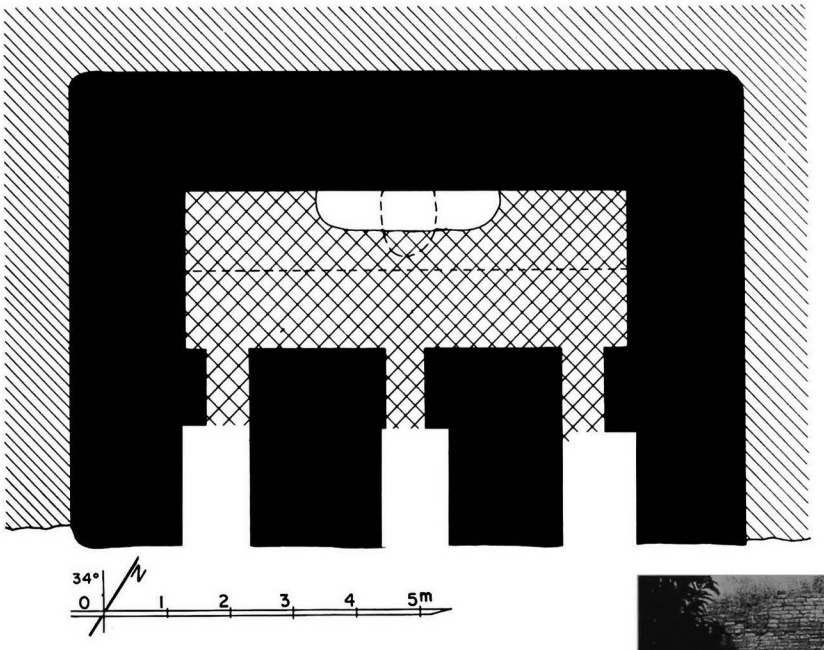
1335 a - Plan

5 present condition
- ruined.
- vault partly collapsed.
- ground floor buried under debris.
